PD-1055 Architectural Shielding Case Study

Objective

To develop and execute a testing plan to replicate a structure to be built in accordance with ICD/ICS-705 and the IC Tech Spec v1.5.1 and to test various shielding materials and installation methods therein. Using this data, the objective is to provide a list of viable materials, installation methods, and their corresponding shielding effectiveness as indicated by the completion of the testing plan.

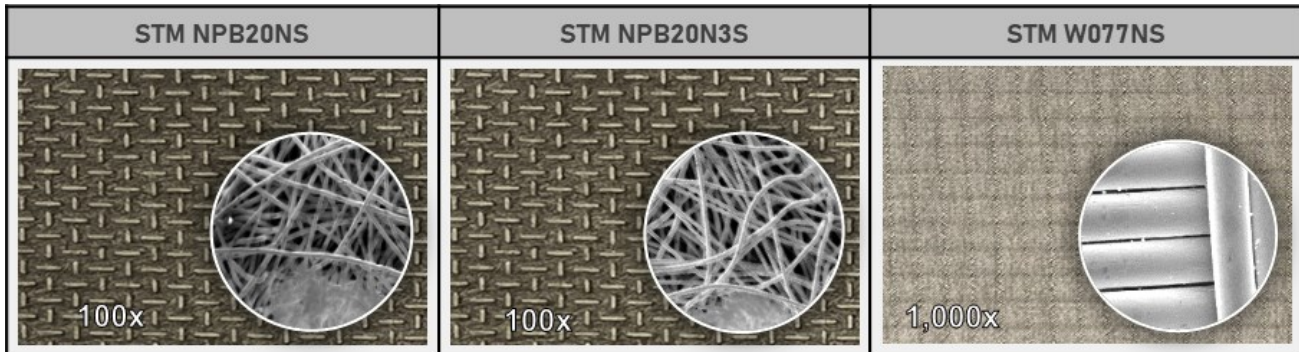
Note: The images above are included to provide an approximate visual representation of the shielding materials used in this project. The 100x magnification of the non-woven materials and 1,000x magnification of the rip stop material are included to demonstrate the complete encapsulation of each fiber that is achieved with STM's proprietary EnCap™ metalization process.

- STM NPB20NS – Electrically Conductive Non-Woven Point Bonded Fabric, Ni Ag Coated, 36" wide
- STM NPB20N3S – Enhanced Electrically Conductive Non-Woven Point Bonded Fabric, Ni Ag Coated, 36" wide
- STM W077NS – Electrically Conductive Nylon Rip Stop, Ni Ag Coated, 36" wide

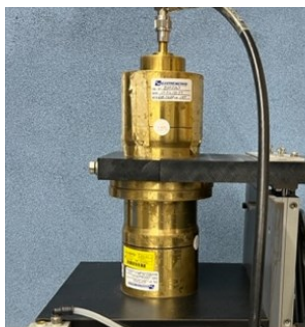
STM split coaxial testing fixture

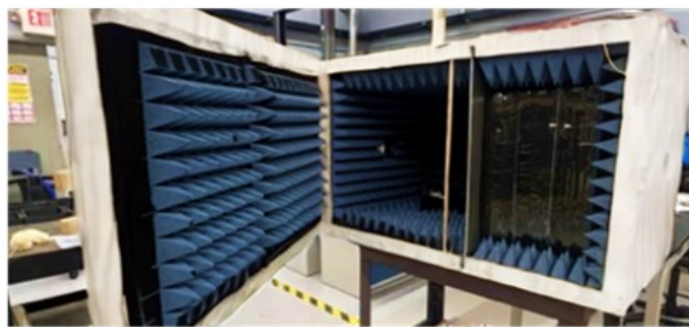
STM free-space transmission loss testing fixture

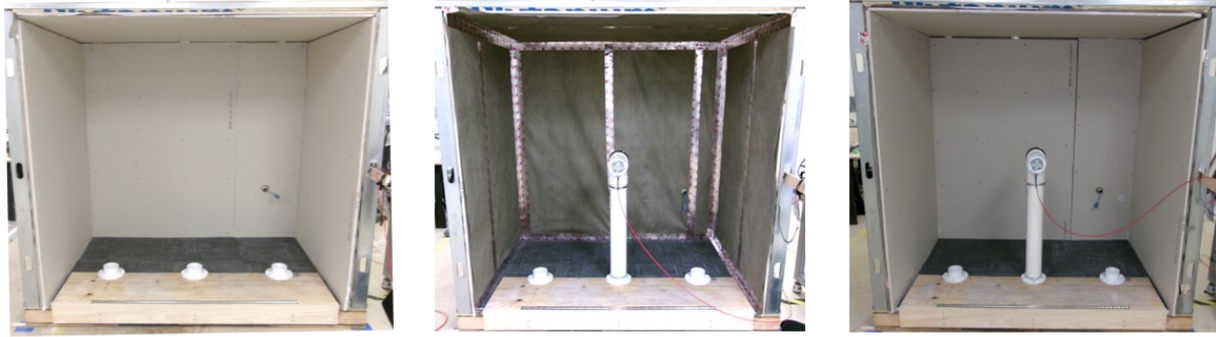
STM Mock ICD-705 Test Structure

Many of the thirteen shielding material configurations are measured at multiple stages of the installation. Depicted above are multiple stages along the installation process: pre-installation, mid-installation, and post-installation. For example, a first test cycle is performed on the base material installation. A second test cycle is performed after seams are taped using foil tape (center). A final test cycle is performed after adding a second layer of drywall over the shielding material configuration (right). STM NPB20N3S – Enhanced Electrically

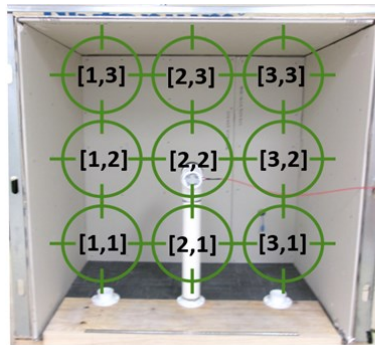
An antenna coordinate system is used to catalogue the free-space transmission loss measurements at nine (9) distinct locations in the test structure in both the V and H polarizations, for a total of 18 measurements per test cycle.

Antenna Coordinate System Illustration

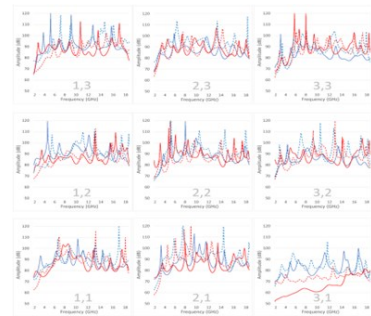
Sample Data Set Illustration

The data sets across all 9 locations, and two polarizations, are averaged to provide an average attenuation. Signal attenuation has been made positive for ease of viewing, but is measured as a negative value indicating signal loss / attenuation.
